**Flood Control Project Maintenance
Levee Inspections**
LMA District Cover Sheet
Spring 2017 Levee Inspection Results

Reclamation District No. 2091 Chase

Spring 2017 Levee Inspection Results

Waterway			Bank	Unit Miles
Unit No. 01 San Joaquin River			Right	7.46
	Spring (March - May)	Summer (June - August)	(September - November) Fall	Winter (December - February)
Unit Maintenance Rating (Fall Only)				
Date of Inspection	4/12/2017 - 4/12/2017			
DWR Inspector	Richard Willoughby			
Accompanied By	Mike Alves RD 2091

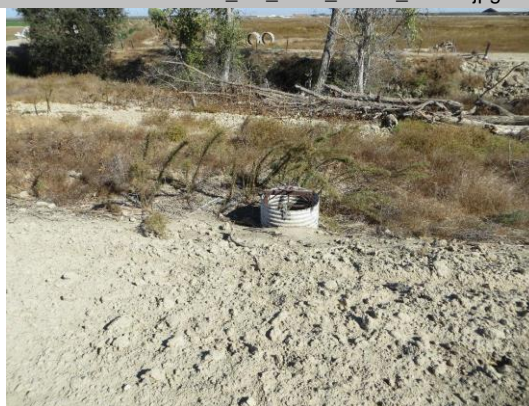
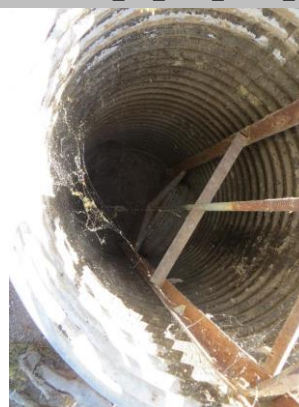
Photo 1 of 3 : UCIP_SP_2017_43207_38148.jpg

LM Start	0.08	Rating **	M	Issue No.	23
LM End	0.08	Issue Type +	Ma	Location *	WS
Category	Supplemental			GPS Latitude/Longitude	
				Start	End
Item	DWR UCIP LMA Responsibility			37.541970 °	37.541970 °
				-121.093980 °	-121.093980 °
DWR ID					
Comment Code					
Inspector Comment					
FS_ID:43207 DS_ID:23155 EP_NO: N/A Repair Type: Non-Urgent Crossing Status: Found UCIP Comments: Appears abandoned and if so should be done so properly. FIELD_STRUCT_DESC: *ABANDONED* 24-inch corrugated metal pipe through levee 7.2 feet below crown. Slide gate in 36-inch corrugated metal pipe riser on the waterward slope. Originally included in the 1961 O&M manual. As built drawings available, Drawing # 07-04-1555: 1555/17 & 1555/55, 906+85. FS Date: 1/29/2015 2:26:31 PM

Slide gate in 36-inch CMP riser on WS toe.

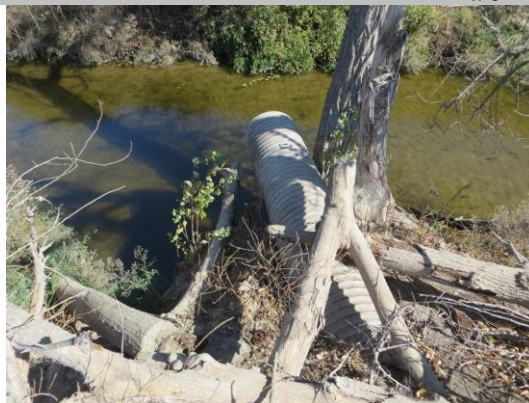
Photo 3 of 3 : UCIP_SP_2017_43207_38146.jpg

LM Start	0.08	Rating **	M	Issue No.	23 (cont)	
LM End	0.08	Issue Type +	Ma	Location *	WS	
Category	Supplemental			GPS Latitude/Longitude		
				Start		End
Item	DWR UCIP LMA Responsibility			37.541970 °		37.541970 °
				-121.093980 °		-121.093980 °
DWR ID						
Comment Code						
Inspector Comment						
FS_ID:43207						
DS_ID:23155						
EP_NO: N/A						
Repair Type: Non-Urgent						
Crossing Status: Found						
UCIP Comments: Appears abandoned and if so should be done so properly.						
FIELD_STRUCT_DESC: *ABANDONED* 24-inch corrugated metal pipe through levee 7.2 feet below crown. Slide gate in 36-inch corrugated metal pipe riser on the waterward slope. Originally included in the 1961 O&M manual. As built drawings available, Drawing # 07-04-1555: 1555/17 & 1555/55, 906+85.						
FS Date: 1/29/2015 2:26:31 PM

CMP stormdrain at outlet off WS toe.

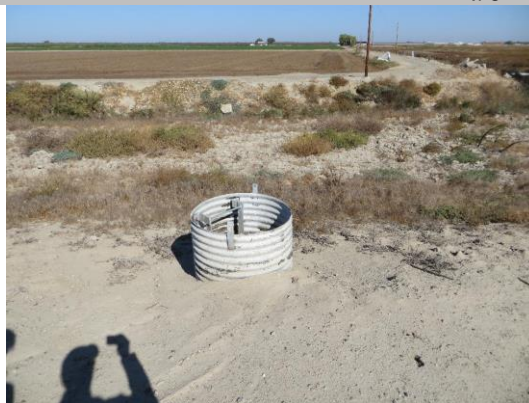
Photo 1 of 3 : UCIP_SP_2017_51387_38150.jpg

LM Start	0.10	Rating **	U	Issue No.	24
LM End	0.10	Issue Type +	Ma	Location *	WS
Category	Supplemental			GPS Latitude/Longitude	
				Start	End
Item	DWR UCIP LMA Responsibility			37.542030 °	37.542030 °
				-121.094370 °	-121.094370 °
DWR ID

Comment Code					
Inspector Comment					
FS_ID:51387 DS_ID:23156 EP_NO: N/A Repair Type: Urgent Crossing Status: Found UCIP Comments: 11/18/2016 Same as last inspection this is a non-functional crossing with no visible inlet on LS or outlet on WS. The only appurtenance found at this location is a CMP riser with a missing cover located on the WS. This crossing remains Urgent since the pipe on the WS may still be opened. According to Mike Alves, this crossing is abandoned and the City of Modesto is working with CVFPB to authorize proper abandonment/removal. The City is working at finding funds to pay for proper abandonment/removal of all the drainage structures through this levee. (O. Magana - DWR UCIP)01/29/2015 Pipe open on WS and slide gate has been removed. Appears abandoned and should be done so properly. (M. Alves - City of Modesto) FIELD_STRUCT_DESC: *ABANDONED* 24-inch corrugated metal drainage pipe through levee, 9 feet below crown. Slide gate in corrugated metal pipe (CMP) riser located on the waterside (WS) slope. [Additional Reference(s): DWR Levee Log, 1992. USACE San Joaquin River O&M Manual Unit 6, September 1961, (HLM 0.07), Drawing No. 07-04-1555, sheet(s) 1555/17 and 1555/55, reference station 907+55]. FS Date: 11/18/2016

36-inch CMP riser on WS slope.

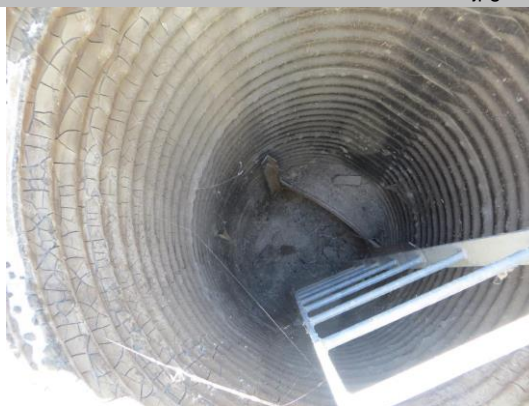
Photo 2 of 3 : UCIP_SP_2017_51387_38149.jpg

Slide gate missing from open end of pipe at WS slope.

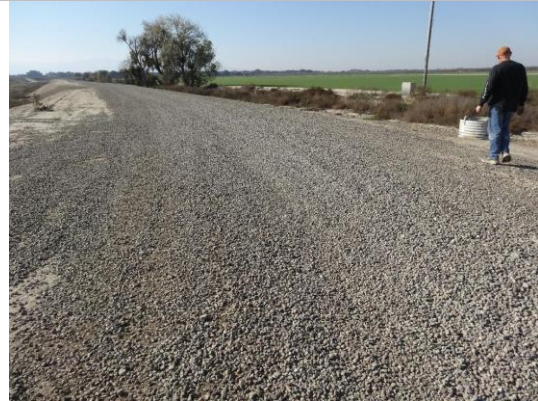
Photo 3 of 3 : UCIP_SP_2017_51387_76669.jpg

Comment Code						
Inspector Comment						
FS_ID:51387 DS_ID:23156 EP_NO: N/A Repair Type: Urgent Crossing Status: Found UCIP Comments: 11/18/2016 Same as last inspection this is a non-functional crossing with no visible inlet on LS or outlet on WS. The only appurtenance found at this location is a CMP riser with a missing cover located on the WS. This crossing remains Urgent since the pipe on the WS may still be opened. According to Mike Alves, this crossing is abandoned and the City of Modesto is working with CVFPB to authorize proper abandonment/removal. The City is working at finding funds to pay for proper abandonment/removal of all the drainage structures through this levee. (O. Magana - DWR UCIP)01/29/2015 Pipe open on WS and slide gate has been removed. Appears abandoned and should be done so properly. (M. Alves - City of Modesto) FIELD_STRUCT_DESC: *ABANDONED* 24-inch corrugated metal drainage pipe through levee, 9 feet below crown. Slide gate in corrugated metal pipe (CMP) riser located on the waterside (WS) slope. [Additional Reference(s): DWR Levee Log, 1992. USACE San Joaquin River O&M Manual Unit 6, September 1961, (HLM 0.07), Drawing No. 07-04-1555, sheet(s) 1555/17 and 1555/55, reference station 907+55]. FS Date: 11/18/2016

Overview of levee crown at pipe crossing.

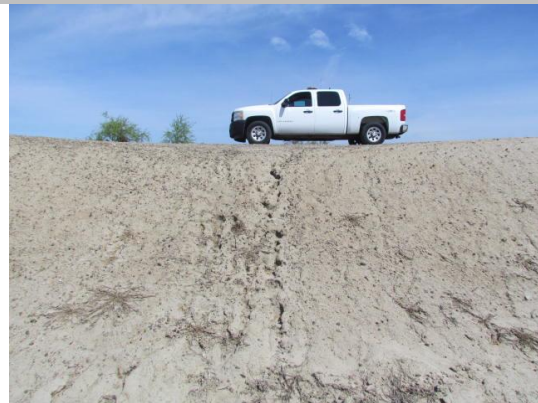
Photo 1 of 4 : SP_2017_RD2091_318_15_20170412_00008.jpg

LM Start	0.23	Rating **	U	Issue No.	15
LM End	0.23	Issue Type +	Ma	Location *	LS
Category	Earthen Levee			GPS Latitude/Longitude	
				Start	End
Item	Erosion / Bank Caving			37.541550 °	37.541550 °
				-121.096742 °	-121.096742 °
DWR ID	DWR_RD2091_01_s_2016_15				
Comment Code					
E1 : Note and monitor erosion site.					
Inspector Comment					
Caving on landward shoulder possible collapsed pipe. Caving is 34 feet long over one inch depth.

Looking west at dip on landward levee shoulder.

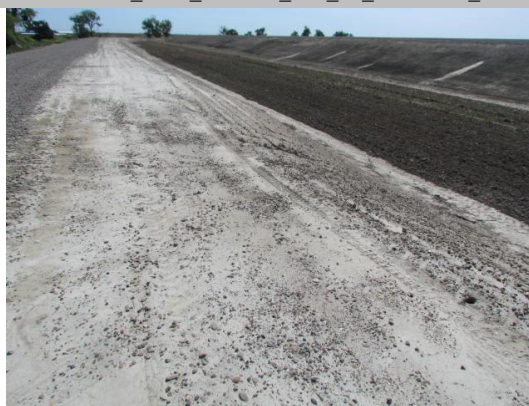
Photo 2 of 4 : SP_2017_RD2091_318_15_20170412_00009.jpg

LM Start	0.23	Rating **	U	Issue No.	15 (cont)	
LM End	0.23	Issue Type +	Ma	Location *	LS	
Category	Earthen Levee			GPS Latitude/Longitude		
				Start		End
Item	Erosion / Bank Caving			37.541550 °		37.541550 °
				-121.096742 °		-121.096742 °
DWR ID	DWR_RD2091_01_s_2016_15					
Comment Code						
E1 : Note and monitor erosion site.						
Inspector Comment						
Caving on landward shoulder possible collapsed pipe. Caving is 34 feet long over one inch depth.

Looking southeast at depression along landward shoulder.

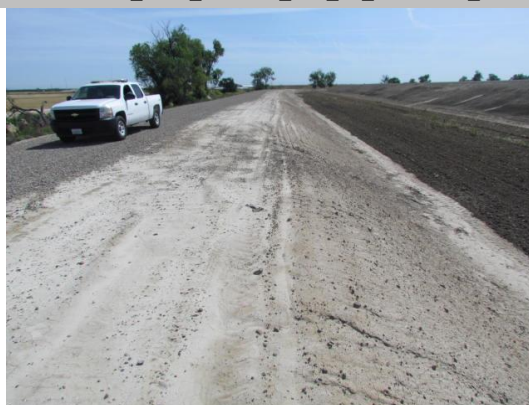
Photo 3 of 4 : SP_2017_RD2091_318_15_20170412_00010.jpg

Looking south at depression along landward shoulder.

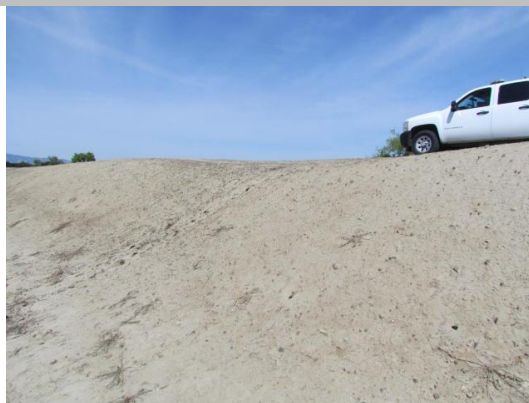
Photo 4 of 4 : SP_2017_RD2091_318_15_20170412_00011.jpg

Looking northwest at depression along landward shoulder.

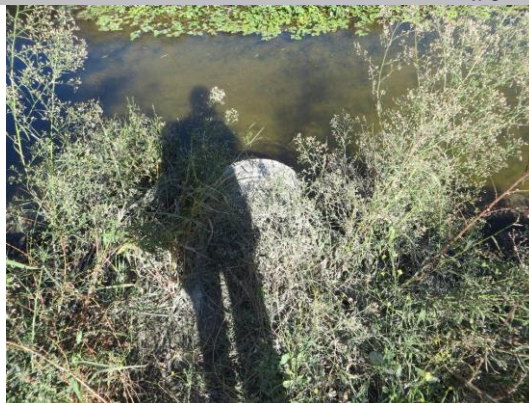
Photo 1 of 3 : UCIP_SP_2017_51388_38156.jpg

Comment Code					
Inspector Comment					
FS_ID:51388 DS_ID:23158 EP_NO: N/A Repair Type: Urgent Crossing Status: Found UCIP Comments: 11/18/2016 Same as last inspection. This crossing remains Urgent due to the flap gate still missing from the WS toe. According to Mike A. this crossing is an abandoned line and the City of Modesto is working with CVFPB to authorize proper abandonment/removal. The City is working at finding funds to pay for proper abandonment/removal of all the drainage structures through this levee. (O. Magana - DWR UCIP)01/29/2015 Flap gate has fallen off at WS toe. Appears abandoned and if so should be done so properly. (M. Alves - City of Modesto) FIELD_STRUCT_DESC: *ABANDONED* 24-inch corrugated metal drainage pipe through levee, 10 feet below crown. Flap gate located on the waterside (WS) end. Drain opening is located approximately 15 feet off the landside (LS) toe. [Additional Reference(s): DWR Levee Log, 1992. USACE San Joaquin River O&M Manual Unit 6, September 1961, (HLM 0.23), Drawing No. 07-04-1555, sheet(s) 1555/17 and 1555/55, reference station 915+00]. FS Date: 11/18/2016

Pipe visible in canal on WS toe.

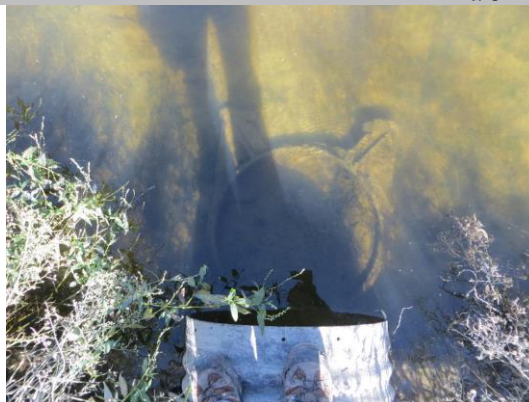
Photo 2 of 3 : UCIP_SP_2017_51388_38155.jpg

Flapgate has fallen off at WS toe.

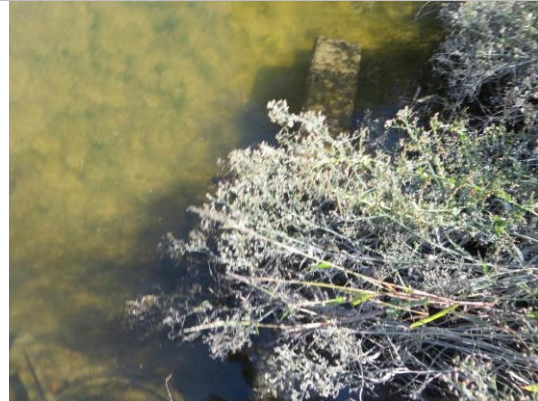
Photo 3 of 3 : UCIP_SP_2017_51388_38154.jpg

Comment Code					
Inspector Comment					
FS_ID:51388 DS_ID:23158 EP_NO: N/A Repair Type: Urgent Crossing Status: Found UCIP Comments: 11/18/2016 Same as last inspection. This crossing remains Urgent due to the flap gate still missing from the WS toe. According to Mike A. this crossing is an abandoned line and the City of Modesto is working with CVFPB to authorize proper abandonment/removal. The City is working at finding funds to pay for proper abandonment/removal of all the drainage structures through this levee. (O. Magana - DWR UCIP)01/29/2015 Flap gate has fallen off at WS toe. Appears abandoned and if so should be done so properly. (M. Alves - City of Modesto) FIELD_STRUCT_DESC: *ABANDONED* 24-inch corrugated metal drainage pipe through levee, 10 feet below crown. Flap gate located on the waterside (WS) end. Drain opening is located approximately 15 feet off the landside (LS) toe. [Additional Reference(s): DWR Levee Log, 1992. USACE San Joaquin River O&M Manual Unit 6, September 1961, (HLM 0.23), Drawing No. 07-04-1555, sheet(s) 1555/17 and 1555/55, reference station 915+00]. FS Date: 11/18/2016

Concrete headwall under pipe at WS toe.

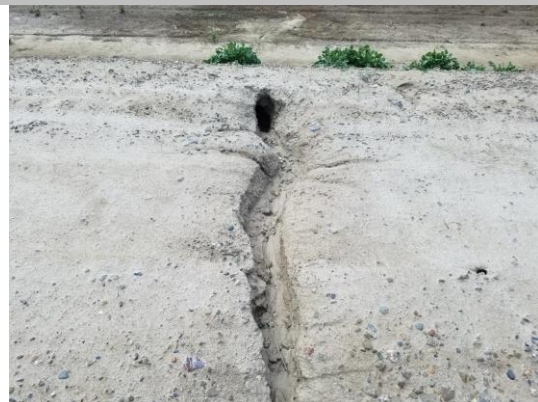
Photo 1 of 3 : SP_2017_RD2091_318_16_20170412_00044.jpg

LM Start	0.25	Rating **	M	Issue No.	16
LM End	0.28	Issue Type +	Ma	Location *	LS
Category	Earthen Levee			GPS Latitude/Longitude	
				Start	End
Item	Erosion / Bank Caving			37.541492 °	37.541408 °
				-121.097052 °	-121.097453 °
DWR ID	DWR_RD2091_01_s_2016_16				
Comment Code					
E1 : Note and monitor erosion site.					
Inspector Comment					
Several sites of rill erosion and possible rodent holes along landward shoulder and slope.

Looking east at rill erosion above rodent hole on landward slope. (Spring 2017)

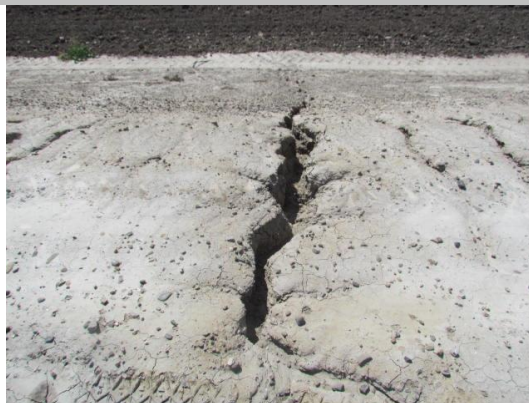
Photo 2 of 3 : SP_2017_RD2091_318_16_20170412_00012.jpg

Looking east at rill erosion on landward slope.

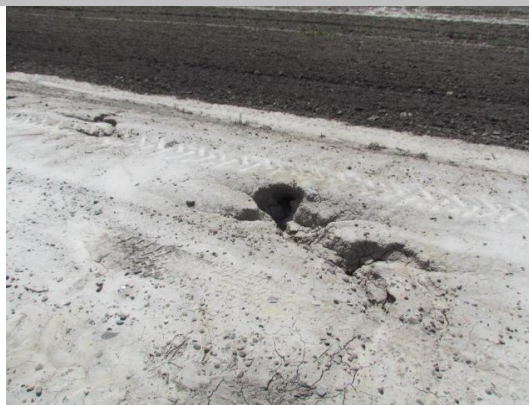
Photo 3 of 3 : SP_2017_RD2091_318_16_20170412_00013.jpg

Looking east at rill erosion and possible rodent hole on landward slope.

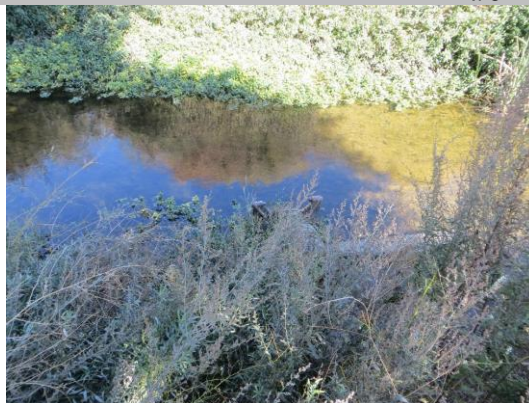
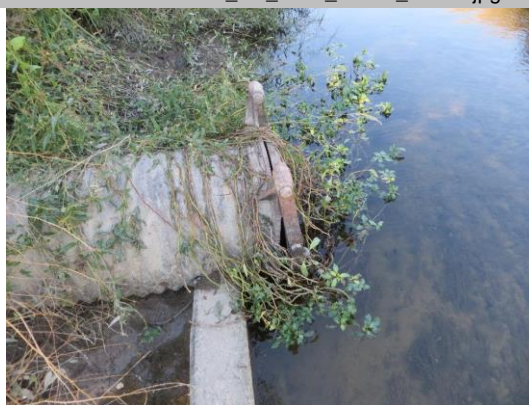
Photo 1 of 3 : UCIP_SP_2017_51639_38158.jpg

FS_ID:51639
DS_ID:23161
EP_NO: N/A
Repair Type: Non-Urgent
Crossing Status: Found
UCIP Comments: 11/18/2016 Crossing has been downgraded from Urgent to Non-Urgent since the flap gate appears to fully close. According to Mike Alvez, this crossing is abandoned and the City of Modesto is working with CVFPB to authorize proper abandonment/removal. The City is working at finding funds to pay for proper abandonment/removal of all the drainage structures through this levee. (O. Magana - DWR UCIP)01/29/2015 Appears abandoned and if so should be done so properly. (M. Alvez - City of Modesto)
FIELD_STRUCT_DESC: *ABANDONED* 24-inch corrugated metal drainage pipe through levee, 12 feet below crown. Flap gate and concrete headwall are located on the waterside (WS) end. [Additional Reference(s): DWR Levee Log, 1992. USACE San Joaquin River O&M Manual Unit 6, September 1961, (HLM 0.64)].
FS Date: 11/18/2016

24-inch CMP on concrete headwall with flapgate on WS toe.

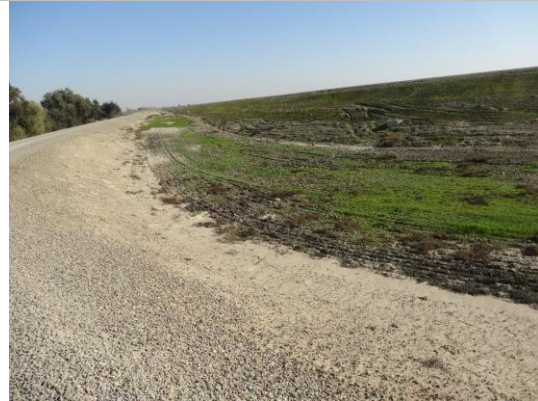
Photo 3 of 3 : UCIP_SP_2017_51639_76677.jpg

Comment Code					
Inspector Comment					
FS_ID:51639 DS_ID:23161 EP_NO: N/A Repair Type: Non-Urgent Crossing Status: Found UCIP Comments: 11/18/2016 Crossing has been downgraded from Urgent to Non-Urgent since the flap gate appears to fully close. According to Mike Alvez, this crossing is abandoned and the City of Modesto is working with CVFPB to authorize proper abandonment/removal. The City is working at finding funds to pay for proper abandonment/removal of all the drainage structures through this levee. (O. Magana - DWR UCIP)01/29/2015 Appears abandoned and if so should be done so properly. (M. Alvez - City of Modesto) FIELD_STRUCT_DESC: *ABANDONED* 24-inch corrugated metal drainage pipe through levee, 12 feet below crown. Flap gate and concrete headwall are located on the waterside (WS) end. [Additional Reference(s): DWR Levee Log, 1992. USACE San Joaquin River O&M Manual Unit 6, September 1961, (HLM 0.64)]. FS Date: 11/18/2016

View of LS.

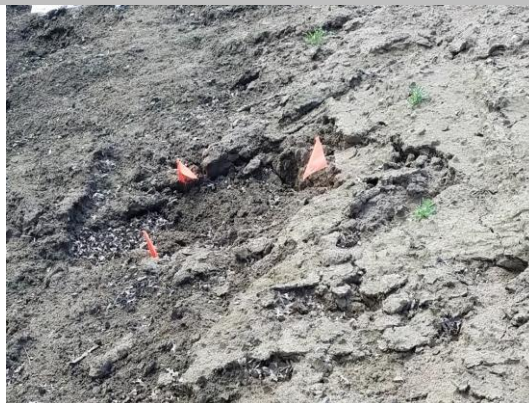
Photo 1 of 1 : SP_2017_RD2091_318_21_20170412_00045.jpg

LM Start	3.91	Rating **	M	Issue No.	21
LM End	3.91	Issue Type +	Ma	Location *	LS
Category	Earthen Levee			GPS Latitude/Longitude	
				Start	End
Item	Erosion / Bank Caving			37.506815 °	37.506815 °
				-121.082780 °	-121.082780 °
DWR ID	DWR_RD2091_01_s_2017_21				
Comment Code					
E2 : Schedule repair of erosion site prior to the next inspection.					
Inspector Comment					
Sinkhole at landward side toe

Looking south at possible sinkhole on landward toe.

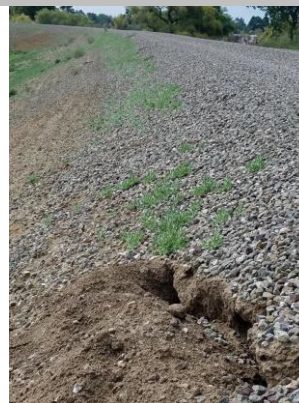
Photo 1 of 1 : SP_2017_RD2091_318_22_20170412_00046.jpg

LM Start	4.25	Rating **	M	Issue No.	22
LM End	4.25	Issue Type +	Ma	Location *	LS
Category	Earthen Levee			GPS Latitude/Longitude	
				Start	End
Item	Animal Control			37.501907 °	37.501907 °
				-121.082123 °	-121.082123 °
DWR ID	DWR_RD2091_01_s_2017_22				
Comment Code					
A3 : No rodents visible, but rodent burrows visible; need to backfill and compact or grout burrows.					
Inspector Comment

Looking south at rodent activity on landward shoulder and slope.

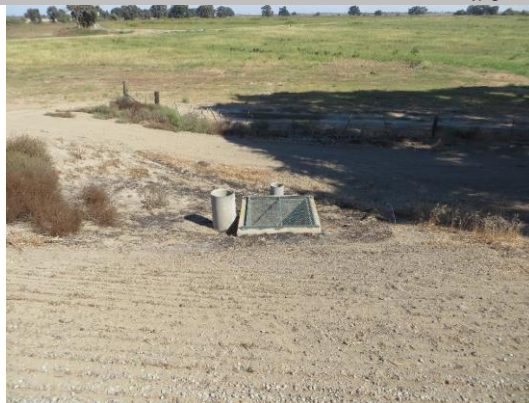
Photo 1 of 3 : UCIP_SP_2017_43209_38211.jpg

LM Start	4.59	Rating **	M	Issue No.	27
LM End	4.59	Issue Type +	En	Location *	LS
Category	Supplemental			GPS Latitude/Longitude	
				Start	End
Item	DWR UCIP Field Study			37.497390 °	37.497390 °
				-121.080370 °	-121.080370 °
DWR ID					
Comment Code					
Inspector Comment					
FS_ID:43209 DS_ID:23165 EP_NO: N/A Repair Type: Non-Urgent Crossing Status: Found UCIP Comments: Appears abandoned and if so should be done so properly. FIELD_STRUCT_DESC: 36-inch corrugated metal pipe through levee 15.0 feet below crown. Abandoned concrete inlet box on the waterward slope of levee. 6'X5' Concrete distribution box at the landward toe. Originally included in the 1961 O&M manual. FS Date: 1/29/2015 2:27:42 PM

Distribution box on LS toe.

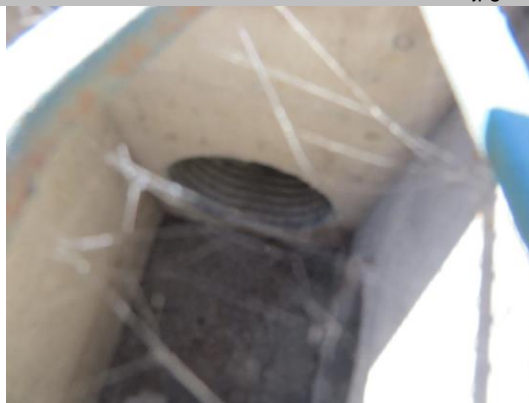
Photo 2 of 3 : UCIP_SP_2017_43209_38210.jpg

Open CMP pipe through levee at distribution box on LS toe.

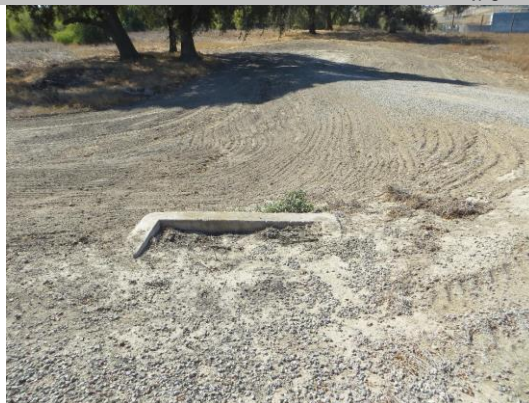
Photo 3 of 3 : UCIP_SP_2017_43209_38209.jpg

LM Start	4.59	Rating **	M	Issue No.	27 (cont)	
LM End	4.59	Issue Type +	En	Location *	LS	
Category	Supplemental			GPS Latitude/Longitude		
				Start	End	
Item	DWR UCIP Field Study			37.497390 °	37.497390 °	
				-121.080370 °	-121.080370 °	
DWR ID						
Comment Code						
Inspector Comment						
FS_ID:43209						
DS_ID:23165						
EP_NO: N/A						
Repair Type: Non-Urgent						
Crossing Status: Found						
UCIP Comments: Appears abandoned and if so should be done so properly.						
FIELD_STRUCT_DESC: 36-inch corrugated metal pipe through levee 15.0 feet below crown. Abandoned concrete inlet box on the waterward slope of levee. 6'X5' Concrete distribution box at the landward toe.						
Originally included in the 1961 O&M manual.						
FS Date: 1/29/2015 2:27:42 PM

Abandoned concrete box on WS slope.

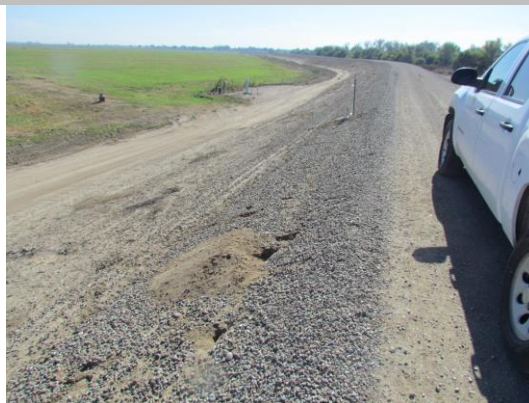
Photo 1 of 3 : SP_2017_RD2091_318_10_20170412_00001.jpg

LM Start	4.85	Rating **	U	Issue No.	10
LM End	4.85	Issue Type +	Ma	Location *	LS
Category	Earthen Levee			GPS Latitude/Longitude	
				Start	End
Item	Animal Control			37.494115 °	37.494115 °
				-121.078100 °	-121.078100 °
DWR ID	DWR_RD2091_01_f_2016_10				
Comment Code					
A3 : No rodents visible, but rodent burrows visible; need to backfill and compact or grout burrows.					
Inspector Comment					
Several large rodent holes on landward slope.

Looking south at several rodent holes on landward slope.

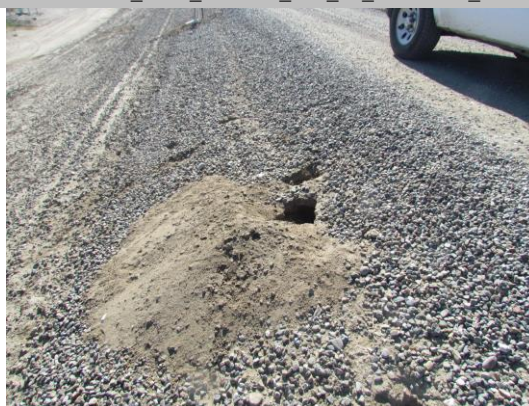
Photo 2 of 3 : SP_2017_RD2091_318_10_20170412_00002.jpg

Looking south at close-up view of rodent holes on landward slope.

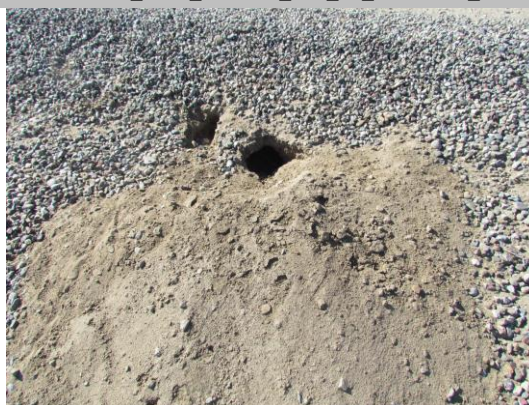
Photo 3 of 3 : SP_2017_RD2091_318_10_20170412_00003.jpg

Looking west at close-up view of rodent holes on landward slope.

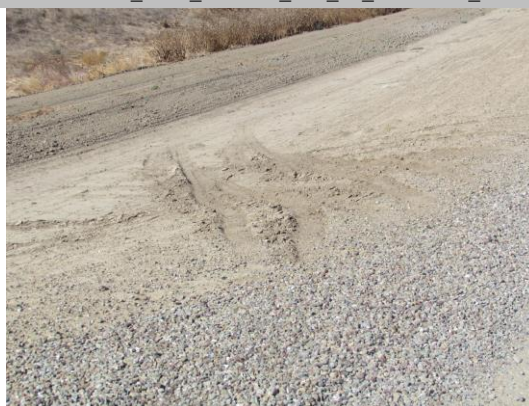
Photo 1 of 2 : SP_2017_RD2091_318_13_20170412_00006.jpg

LM Start	5.20	Rating **	M	Issue No.	13
LM End	5.20	Issue Type +	Ma	Location *	LS
Category	Earthen Levee			GPS Latitude/Longitude	
				Start	End
Item	Slope Stability			37.490756 °	37.490756 °
				-121.073410 °	-121.073410 °
DWR ID	DWR_RD2091_01_f_2016_13				
Comment Code					
S3 : Repair the levee slope damaged by vehicle traffic and prevent access where possible.					
Inspector Comment					
Vehicle traffic damaging slope on waterward and landward slope.

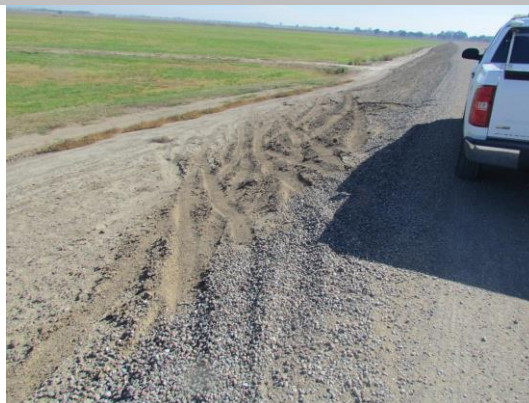
Photo 2 of 2 : SP_2017_RD2091_318_13_20170412_00007.jpg

LM Start	5.20	Rating **	M	Issue No.	13 (cont)	
LM End	5.20	Issue Type +	Ma	Location *	LS	
Category	Earthen Levee			GPS Latitude/Longitude		
				Start		End
Item	Slope Stability			37.490756 °		37.490756 °
				-121.073410 °		-121.073410 °
DWR ID	DWR_RD2091_01_f_2016_13					
Comment Code						
S3 : Repair the levee slope damaged by vehicle traffic and prevent access where possible.						
Inspector Comment						
Vehicle traffic damaging slope on waterward and landward slope.

Looking at damage on waterward slope.

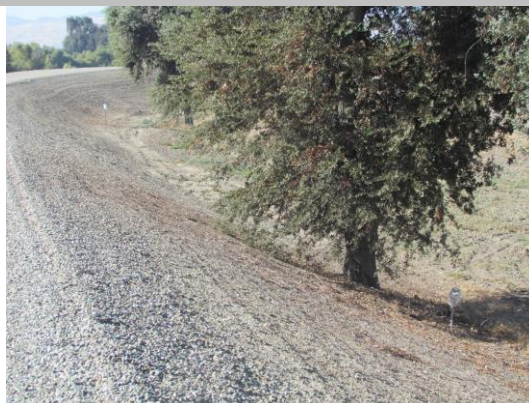
Photo 1 of 2 : SP_2017_RD2091_318_12_20170412_00004.jpg

LM Start	5.92	Rating **	M	Issue No.	12
LM End	5.92	Issue Type +	Ma	Location *	LS
Category	Earthen Levee			GPS Latitude/Longitude	
				Start	End
Item	Trim / Thin Trees			37.485998 °	37.485998 °
				-121.063323 °	-121.063323 °
DWR ID	DWR_RD2091_01_f_2015_12				
Comment Code					
T1 : Trim trees to at least five feet above ground level.					
Inspector Comment

Looking north at untrimmed tree at landward toe.

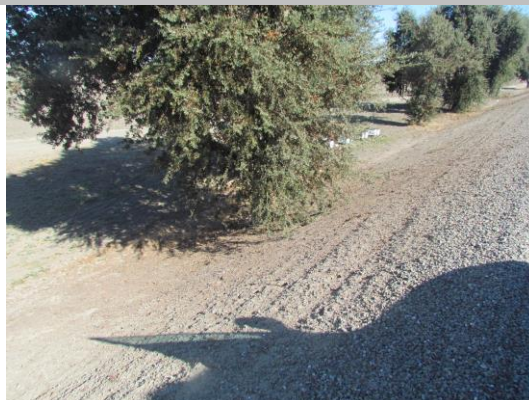
Photo 2 of 2 : SP_2017_RD2091_318_12_20170412_00005.jpg

Look southeast at untrimmed tree at landward toe.

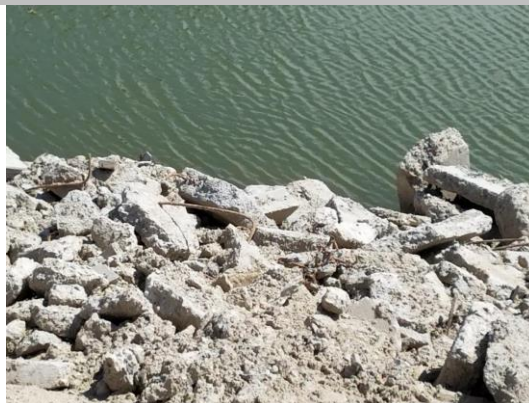
Photo 1 of 2 : SP_2017_RD2091_318_8_20170412_00047.jpg

LM Start	7.42	Rating **	U	Issue No.	8
LM End	7.45	Issue Type +	Ma	Location *	LS
Category	Earthen Levee			GPS Latitude/Longitude	
				Start	End
Item	Erosion / Bank Caving			37.479308 °	37.478998 °
				-121.044708 °	-121.044660 °
DWR ID	DWR_RD2091_01_s_2017_8				
Comment Code					
E2 : Schedule repair of erosion site prior to the next inspection.					
Inspector Comment					
Repaired area with concrete containing rebar. Need to remove rebar.

Looking east at concrete rubble with rebar at landward toe next to canal.

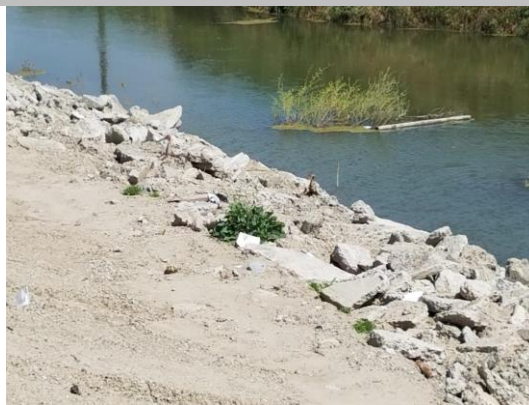
Photo 2 of 2 : SP_2017_RD2091_318_8_20170412_00048.jpg

Looking northeast at concrete rubble with rebar at landward toe next to canal.

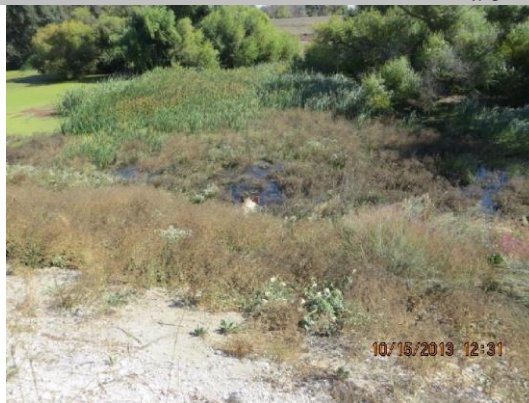
Photo 1 of 3 : UCIP_SP_2017_51390_38216.jpg

FS_ID:51390
DS_ID:23175
EP_NO: N/A
Repair Type: Non-Urgent
Crossing Status: Found
UCIP Comments: 11/18/2016 Same as last inspection. This is a non-functional crossing with flap gate in the closed position. This crossing has been downgraded from Urgent to Non-Urgent -- no integrity issues were observed on the levee crown or slopes. According to Mike A. this crossing is abandoned and the City of Modesto is working with CVFPB to authorize proper abandonment/removal. The City is working at finding funds to pay for proper abandonment/removal of all the drainage structures through this levee. (O. Magana - DWR UCIP)01/29/2015
Flap gate rusted in-place and does not function. In closed position. (M. Alves - City of Modesto)
FIELD_STRUCT_DESC: 24-inch corrugated metal drainage pipe through levee, 16.4 feet below the crown. Flap gate is located on the waterside (WS) toe. [Additional Reference(s): DWR Levee Log, 1992].

24-inch CMP with flapgate visible on WS toe.

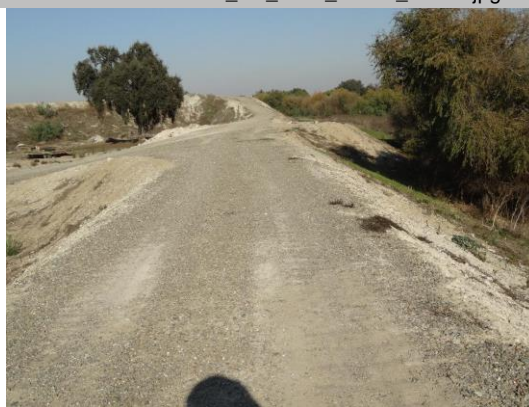
Photo 2 of 3 : UCIP_SP_2017_51390_76689.jpg

Overview photo of levee crown at crossing.

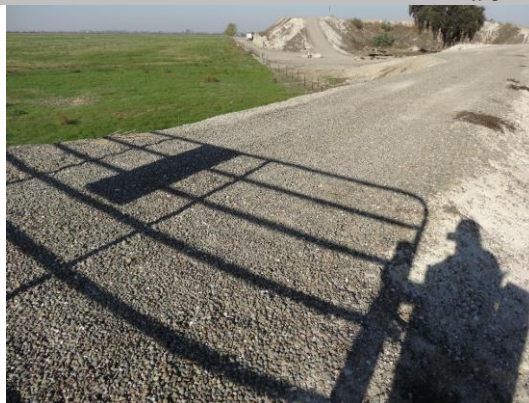
Photo 3 of 3 : UCIP_SP_2017_51390_76686.jpg

Comment Code						
Inspector Comment						
FS_ID:51390 DS_ID:23175 EP_NO: N/A Repair Type: Non-Urgent Crossing Status: Found UCIP Comments: 11/18/2016 Same as last inspection. This is a non-functional crossing with flap gate in the closed position. This crossing has been downgraded from Urgent to Non-Urgent -- no integrity issues were observed on the levee crown or slopes. According to Mike A. this crossing is abandoned and the City of Modesto is working with CVFPB to authorize proper abandonment/removal. The City is working at finding funds to pay for proper abandonment/removal of all the drainage structures through this levee. (O. Magana - DWR UCIP)01/29/2015 Flap gate rusted in-place and does not function. In closed position. (M. Alves - City of Modesto) FIELD_STRUCT_DESC: 24-inch corrugated metal drainage pipe through levee, 16.4 feet below the crown. Flap gate is located on the waterside (WS) toe. [Additional Reference(s): DWR Levee Log, 1992]. FS Date: 11/18/2016

Overview of levee crown at crossing and at a distance there is a shooting range.
